Manhole Inspection Summary

Manhole # S47I__030MH

Insp Date: **4/23/08 10:48 AM**

Location Address: **427 s chester st** Cross Street: **unnamed alley**

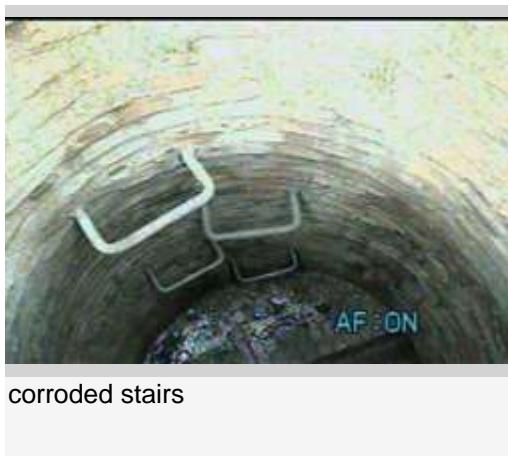
Defect 3

Steps Count: **5** Missing: **1** ☒ **Corroded**

corroded stairs

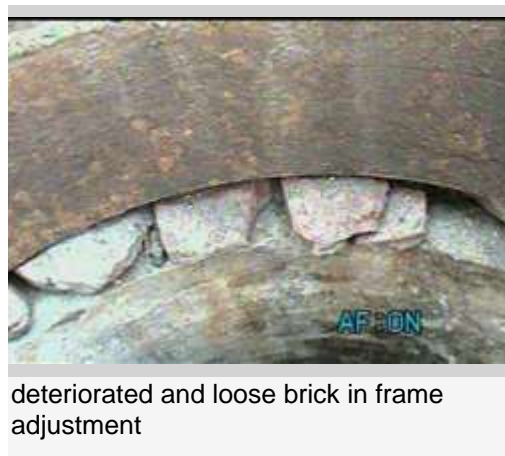
Defect 2

Condition: ☐ Sound ☐ Cracked ☐ Root Intrusion ☒ **Loose Brick** ☒ **Deteriorated**

deteriorated and loose brick in frame adjustment

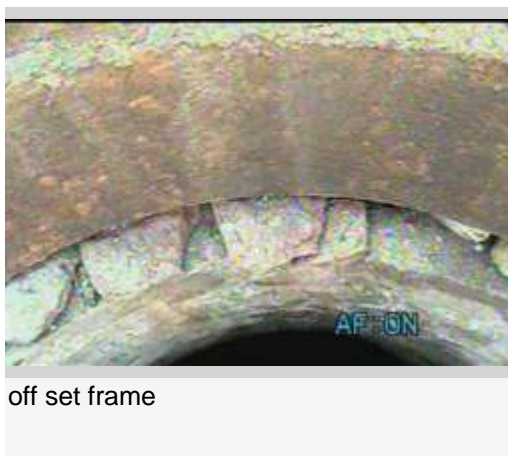
Defect 1

Frame Offset: **2** (in.) Condition: ☒ Sound ☐ Cracked ☐ Leaks

off set frame
